# **SEISMIC RESILIENCE OF AN ASPHALT FACING ROCKFILL DAM (AFRD) IN SOUTHERN ITALY<sup>1</sup>**

*Geotecna Progetti – Consulting Engineers – Milano*

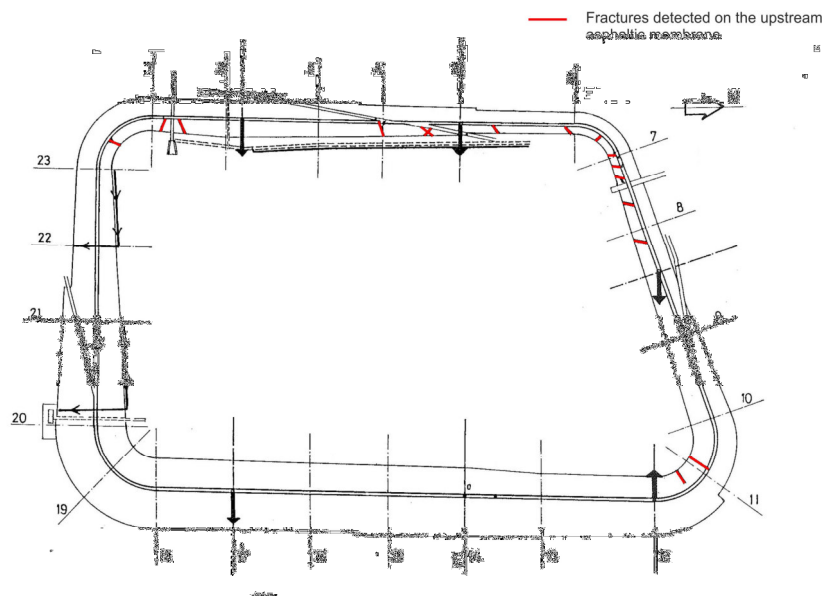
Figure 4

In fact it was interested by cracks (Figure 4), mostly observed in the curves of the embankment and in proximity of the auxiliary structures in reinforced concrete (inlet and spillway), or next to the embankment discontinuities. A small part of them, isolated, was observed in the central zone of the West and North sides.

Location of the main cracks of the asphalt facing mapped after the S. Lucia earthquake

The cracks presented well defined characteristics of continuity (from the crest to the water level and sometimes to the foot of the embankment next to the headwall), orientation (almost all diagonal) and opening (equal or less than 1 mm). Another recurring observed element, which would confirm a failure mechanism for tensile stress, is the absence of differential displacements perpendicular to the surface of the face between the edges of the openings.

Some cracks continued on the crest road pavement, crossing it in all its width, and anyway disappeared on the external face.

Evaluated several possible alternatives, in February 1991, in the part of facing above the water level of the reservoir, for a band width of 50 cm across the cracks a graded milling of the entire impervious layer thickness (about 6 cm), was carried out and the restoration of the bituminous conglomerate, with reduced grain-size of the aggregates, was operated.

It consisted in the partial milling of the existing superficial bituminous concrete for a 3 cm thickness (6 cm in correspondence of the cracks) and in the laying of a new impervious layer 8 cm thick, made of modified with termoplastic elastomers bitumen, as well as in the application of a new seal on a total surface of about 30000 m<sup>2</sup>. At the same time all the joints have been renovated in the treated zones.

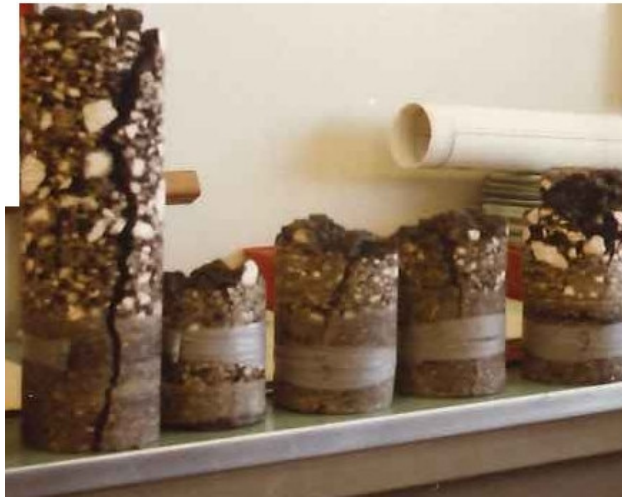
Figure 5

From the examination of the boreholes and of the extracted cores (Figure 5), it was clearly seen that the ruptures affected the entire thickness of the asphaltic membrane.

Characteristics of the ruptures in the asphaltic membrane as observed on the core drillings

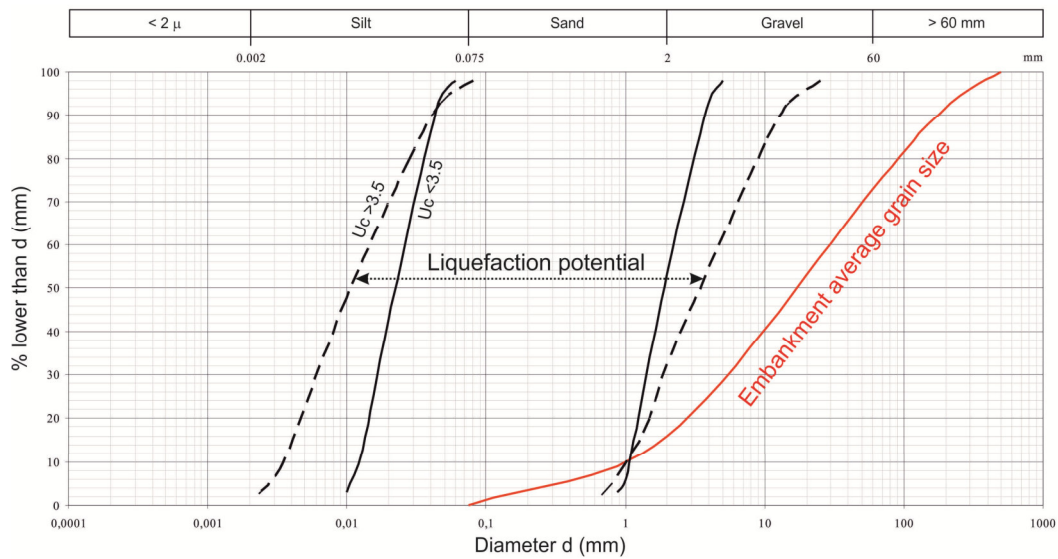
Figure 7

For the granular materials of the embankment, produced crushing the calcarenitic banks present in areas nearby the reservoir, and which are not expected to be saturated due to the presence of the impervious asphaltic membrane on the upstream face, the overall grain-size characteristics ensure the stability to the liquefaction phenomena (Figure 7), despite the high seismicity of the site.

Comparison between the critical grain-size curves for soil liquefaction stability, as fixed by the NTC08 [4], and the average grain-size distribution of the embankment material
