Safety by material restoration of the flood detention basin's weir of the Enza river, Northern Italy.

Abstract

The intervention we are presenting relates to the safety of the flood detention basin's weir of the Enza river, a right tributary of the Po River in Northern Italy. The works concern the restoration of concrete and reinforcements of the weir's glacis and downstream stilling basin, seriously damaged due to the continuous exposure to the water action. As flood detention basins are relatively recent works, the related literature is still scarce. The successful intervention showed numerous innovative aspects, e.g., the construction site's management, which is entirely inside the channel, the adaptation of consolidated techniques to the particular structure's shape and the use of materials, typically employed in different environmental contexts. The amount of collected information makes the intervention an excellent example for the optimization of the qualitative, functional and performance characteristics of future methods aimed at securing similar hydraulic works.

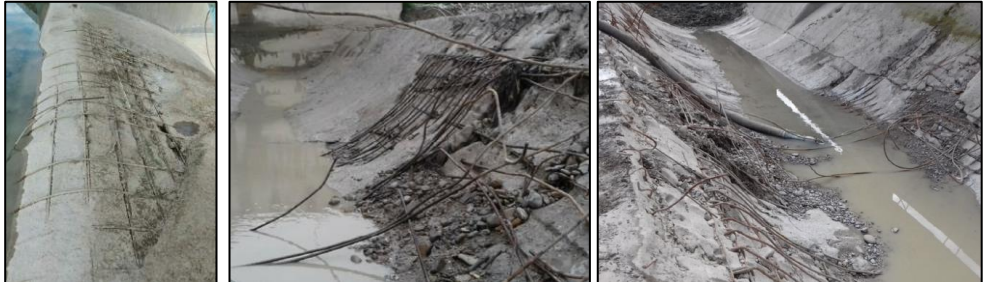
The weir resulted to be considerably abraded and eroded in the downstream glacis and at the bottom of the stilling basin, with an almost constant exposure of the reinforcing bars, which are sometimes not delimited by concrete anymore, instead they are completely external to the theoretical carpentry's profile and sometimes broken (Fig. 2a and 2b). The main causes of deterioration of the structure are:

- carbonation phenomena and freeze-thaw cycles as regards the weir's glacis;
- abrasion/erosion/surface wear regarding the concrete stilling basin.

In the lower part of the weir's glacis, which is frequently in contact with water due to splashes and nebulization phenomena, the aggressions due to a certain number of freeze-thaw cycles were also evident, which resulted in the complete disintegration of the cortical part of the structure.

Suspended particles carried by rivers cause an abrasive action on the structures' contact surface. Furthermore, the flowing discharge produces, with its vortices, actions of depression (cavitation) on the stilling basin's concrete, which tend to tear materials' microscopic parts. This type of physical deterioration represents the main damage cause for channel structures. In our specific case, signs of degradation on the concrete cover were evident, which was considerably cracked and/or detached and/or abraded in extensive areas of the structure. In addition, the stilling basin's concrete in some points was also degraded more in depth, with possible aggression of the reinforcement and reduction of the resistant section of structural elements.

Fig. 2 Damaged reinforcement of the weir's glacis (a) and of the stilling basin (b and c).

As for the weir's glacis, in which the concrete cover was degraded but the aggression didn't hit the reinforcement yet, the intervention aimed at restoring the concrete cover before the degradation would compromise the structure itself. Specifically, the intervention on the weir's glacis included: milling off the cortical part for a minimum thickness of 40 mm up to a maximum of 60 mm in the areas with greater damages; replacement and/or integration of particularly deteriorated reinforcements with new ones with the same diameter; passivation of all reinforcements, both existing and newly placed, with specific products capable, in addition, to increase their adhesion to the restoration mortar; finally, the restoration of the glacis' cortical layer with a premixed thixotropic fiber-reinforced cement-based mortar, class R4, after cleaning and washing the surfaces to be treated, for a thickness of 40-60 mm. Figure 3a shows the weir's glacis at the end of the intervention.

The purpose of the intervention on this part of the weir was to restore the structure's strength, both in terms of sections and/or thicknesses and durability, bringing it back to the initial design conditions, by means of the following processes: hydrodemolition of the surface layer for a depth of 30 mm; milling around existing reinforcements, check of their state of conservation and replacement as needed; application of bar connectors with improved adherence (to increase the very likely impact and rolling resistance of elements on its surface, when works are in the channel) with two-component epoxy resin anchor; passivation of all reinforcements, as for the glacis; reconstruction of the stilling basin's geometry with the use of premixed thixotropic cement-based mortar, class R4, fiber-reinforced with polypropylene fibers with high adhesion to the support and very high compressive strength, for a thickness of 30 mm, after suitable water saturation of the surfaces to be treated. In addition, high-resistance centimetric joints have been made arranged in the flow's direction with a maximum depth of 2 cm, treated and sealed with high-resistance material, so that the surface of the entire structure resulted uniform and without open joints. For areas with very deep degradation, a next-generation concrete was used, obtained with expansive premixed binders with compensated withdrawal, which guarantees much higher performance than traditional concretes; finally, the usual 3 cm surface finish was carried out with the

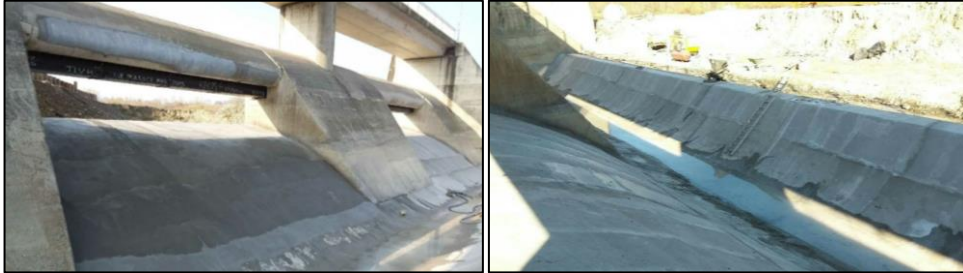
Fig. 3 Weir's glacis (a) and stilling basin (b) after the intervention.

premixed thixotropic fiber-reinforced cement-based mortar, class R4. The finished intervention on the stilling basin is shown in Figure 3b.
